OPERATION
PLUMBBOB

Project 30.2

RESPONSE OF DUAL-PURPOSE
REINFORCED-CONCRETE MASS SHELTER

Issuance Date: September 15, 1962

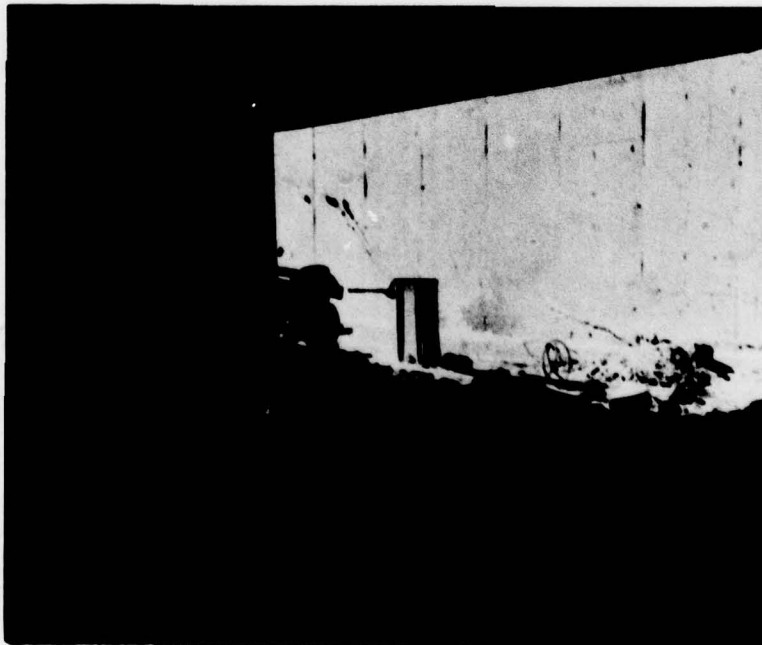
The exposed wall of the garage withstood the blast with no damage. The ramp wall at column line F had several large cracks between the end wall and a point about 30 ft up the ramp (Fig. 3.1). The top of the ramp side wall opposite the door entrance was pushed into the earth about 1 ft at the end. The top edge of the ramp wall farther up the ramp showed little

Fig. 3.1—Cracks in ramp side wall opposite door. View from interior of garage through door opening (postshot).

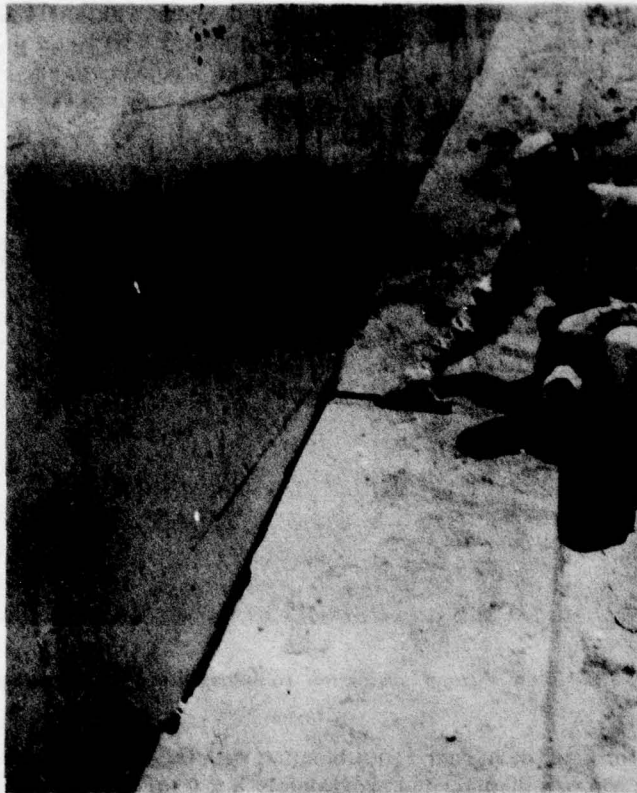
apparent displacement. Although there was no visible damage to the ramp slab, the slab was separated up to $\frac{1}{2}$ in. from the main garage structure at the expansion joint (Fig. 3.2), and the $\frac{1}{2}$ -in. joint filler was blown down or out. Gravel backfill was sucked through the weepers onto the ramp (Fig. 3.3). More gravel was found opposite the weepers at the mid-length and toward the top of the ramp than opposite the weepers at the lower end.

Fig. 3.2—Open joint between ramp slab and wall of main garage structure (postshot).

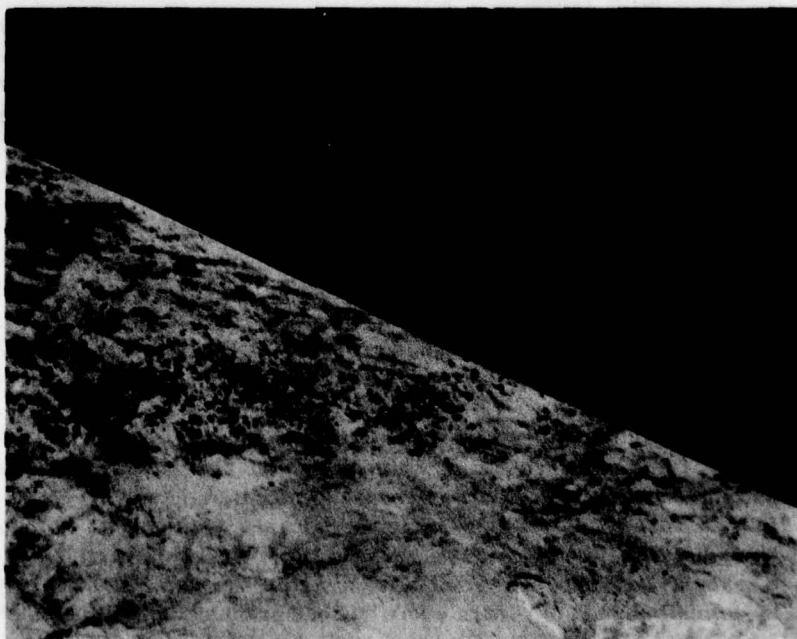
Fig. 3.3—Gravel backfill at weepers (postshot).

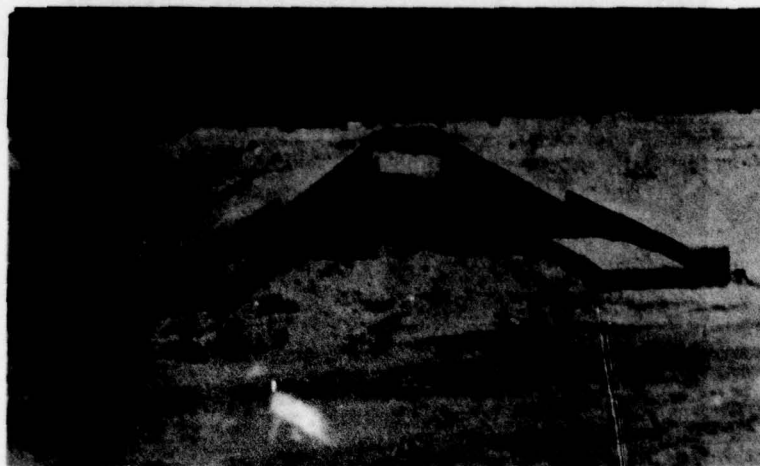
The end wall of the ramp was the only area badly damaged (Figs. 3.4 and 3.5). The top 8 ft of the end wall was broken off as a single unit on a nearly horizontal plane at the top of the splice of the vertical steel. It tipped into the backfill and slipped over the lower section until it wedged tightly between the garage wall and the longitudinal wall of the ramp. It was torn

Fig. 3.4—View of ramp looking toward damaged end wall (postshot).

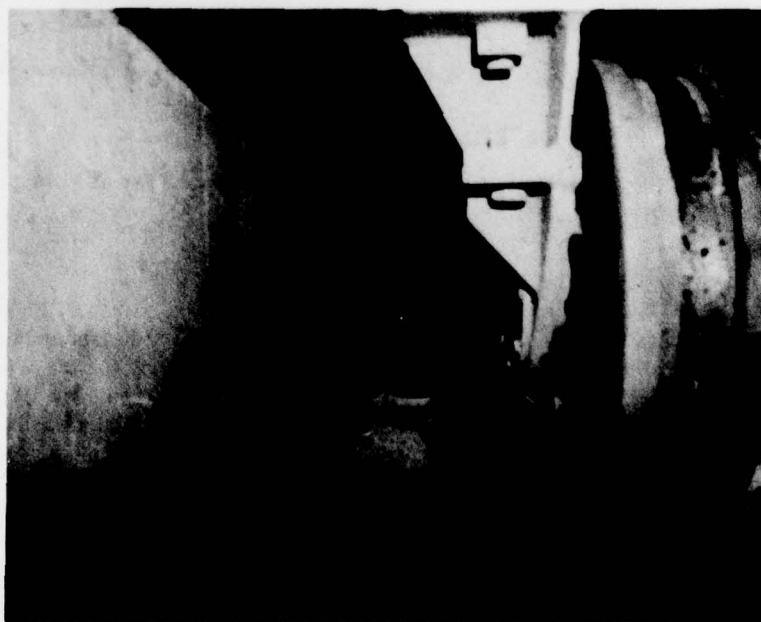
Fig. 3.10— Wheel assembly and rails, door partly open (postshot).
